AUTOMOTIVE SAFETY ENFORCEMENT DIVISION
6601 Ritchie Highway
Glen Burnie, Maryland 21062
(410) 768-1735
FAX (410) 761-2791

SPECIAL ORDER NO. 23-9506

SUBJECT: Rear Window Wipers on Certain Vehicles

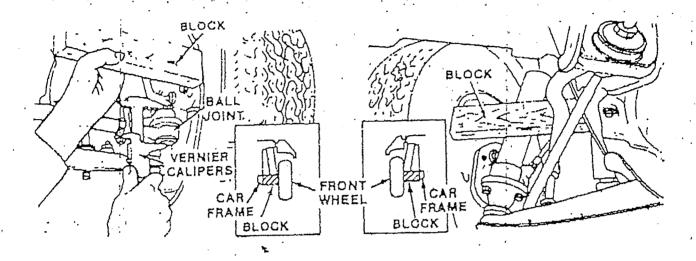
Using a wooden block held between the vehicle frame and the front wheel, turn the steering to the right for the left wheel applying moderate force on the circumference of the steering wheel and measure the tie rod ball joint movement at the stud. should be certain that the block is positioned to make contact at the positions indicated on the illustration so that proper measurements can be made.

Compress the tie rod ball joint stud full stroke, using a pair of pliers, measure the tie rod ball joint axial movement with a vernier caliper. If the axial movement of the tie rod ball joint exceeds tolerance limits (0.059 inch - 1.5 mm) reject the vehicle.
